**PSPE PHILADELPHIA CHAPTER
OUTSTANDING ENGINEERING ACHIEVEMENT AWARD NOMINATION FORM – 2009/2010**

Bridge Reconstruction - Roebling Steel Plant

“ROEBLING BRIDGE

REHABILITATION DESIGN/BUILD”

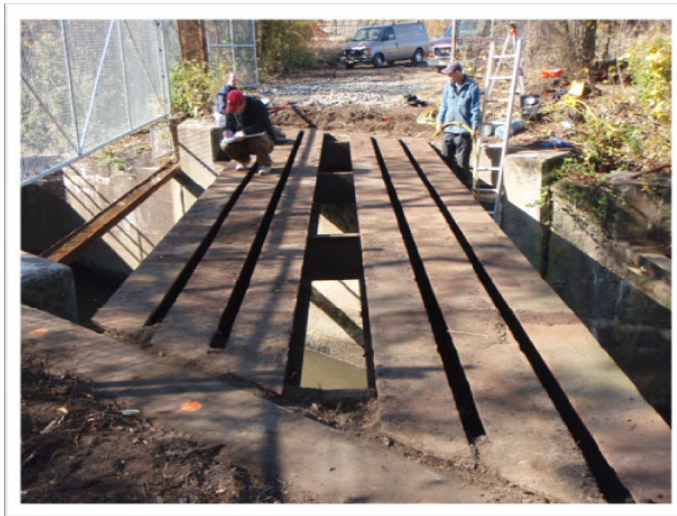
The inspection found the concrete substructure to be in overall good condition with the exception of a void on the abutment at the intersection of the wingwall. The existing superstructure consisted of six 37'-3" long steel 24Gx129 stringers which formerly supported the railroad above. The steel beams were in overall fair condition with section loss and corrosion in the webs and flanges within the end 6'-0"±. Both the steel stringers and the corroded bearing plates would need rehabilitation and repair prior to use. The void located on the abutment would also

have to be repaired. After the inspection, CASTLE determined that if the repairs were made to the bridge, the structure was more than adequate for the re-design.

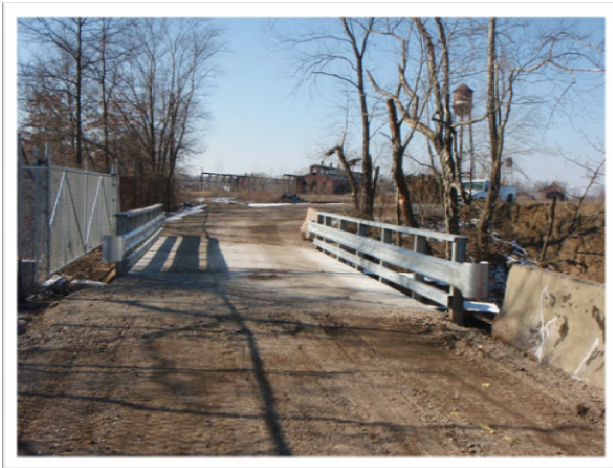
When the stringers were set in their final position the new C8x11.5 diaphragms and the 1½” thick deck pans were installed as well as the ¼” thick bent plate running along the top edges of the fascia beams. Steel guiderail posts were spaced at 6’-3”± and attached to the beams with a ½” thick base plate and to the bridge at the ¼” thick bent plate along the edge of the fascia beams. All steel components of the bridge were covered in epoxy paint with the exception of the galvanized guide rail. The 7” high composite reinforced concrete deck was poured in place in less than one day.
